Service Bulletin for AVT 100/150/275 Static Problem/Dead OD Channel

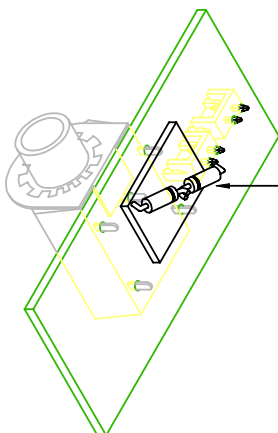
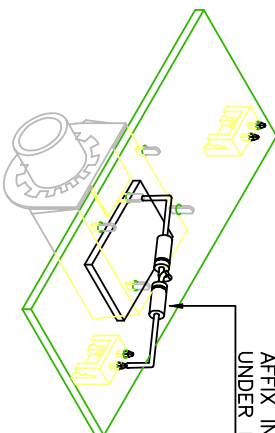
TITLE	STATIC MOD
DWG. No.	SK0000126
ISSUE	A

The problem with overdrive channel failures on the early production runs of AVT 100/150/275's has been identified as being caused by static discharge through the amplifier's input jack socket. An RFC (request for change) procedure has been implemented which will see the fitting of two small zener diodes on the input jack socket boards of these models, which will serve to clamp the static discharge potential to a low, non-destructive level. This will eliminate the present problem. Please view the Static mod schematic on the next page for the correct placement of the two zener diodes.

FIT DIODES AS SHOWN
AFFIX INSULATING PAD
UNDER DIODES.
