## SERVICE BULLETIN #9

## Vibrato "Ticking" Cures

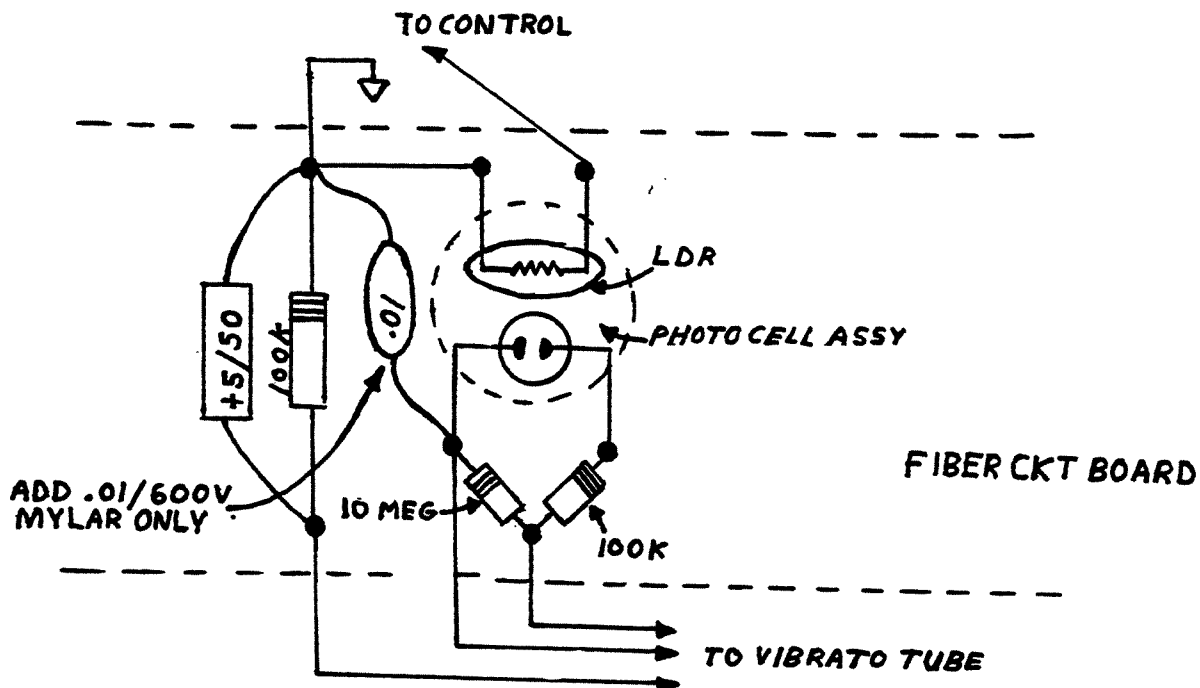
The "ticking" caused by the Vibrato is caused by improper lead dress. It can almost be "cured" by connecting an .01 MFD 600 volt mylar capacitor on the 10 meg ohm resistor in the Vibrator circuit. This resistor is located on the parts panel. Remove capacitor across 10 meg ohm resistor (old modification) if in circuit.

If this does not provide the desired results, then the leads should be dressed as follows and excessive lengths shortened.

1. Dress the leads to the Vibrato speed and intensity controls away from the tone controls and filter leads.
2. "Bunch" the leads to the components on the parts panel which connect to the tube socket of the 7025 (12Ax7A) Vibrato tube.
