# KLARK TEKNIK GROUP

## TECHNICAL BULLETIN

<b>Brand</b> Midas	<b>Reference Number</b> 113	<b>Date</b> 11/10/2002	<input type="checkbox"/> Urgent
<b>Product</b> Legend 3000	<b>Serial Number</b> 3140	<b>Assembly</b> LC321B-2	<input checked="" type="checkbox"/> Recommended
			<input type="checkbox"/> Information Only

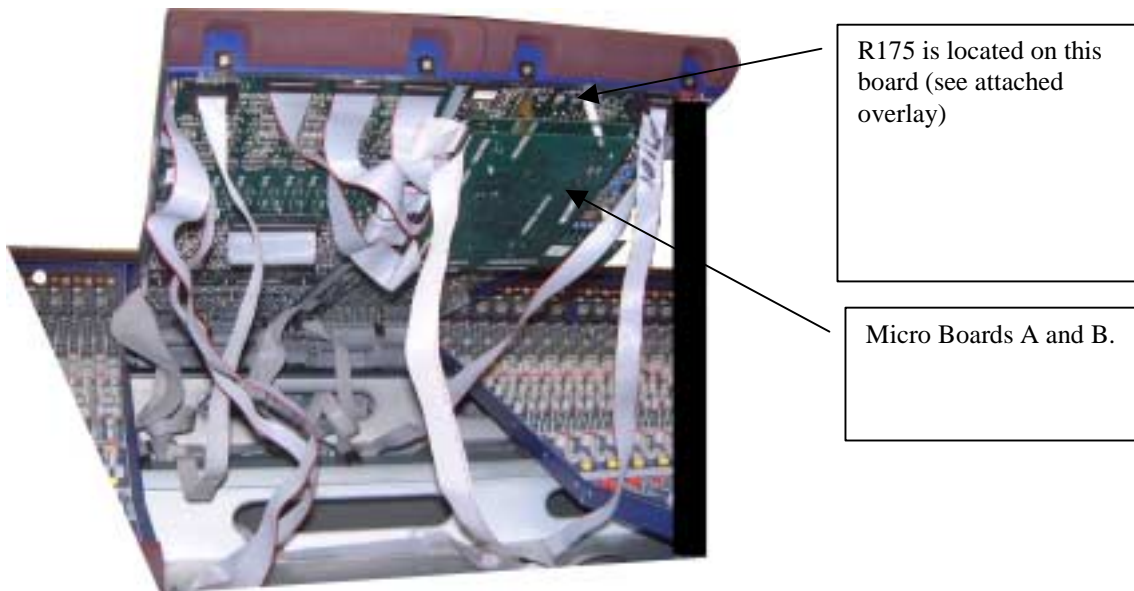
Fig 1. Underside of automation board

**Subject**  
Some customers have noticed an intermittent digital sound in the noise floor of the master outputs of the Legend 3000 console. After investigation this had been found to be due to induced noise from the automation display. This varies in intensity from console to console and is dependent upon component tolerances and the screen display.

This noise is eliminated by changing the value of the refresh rate of the screen. This is achieved by changing the value of R175 located on the underside of the display board, see fig 1.

Located R175 on the underside of the display board and change R175 from a 100k 1% (0603 surface mount package) resistor to a 27k 1% (0603 surface mount package).

If you do not have access to surface mount tools then feel free to contact Midas and a modified board can be arranged for exchange, this is subject to the original board being returned.

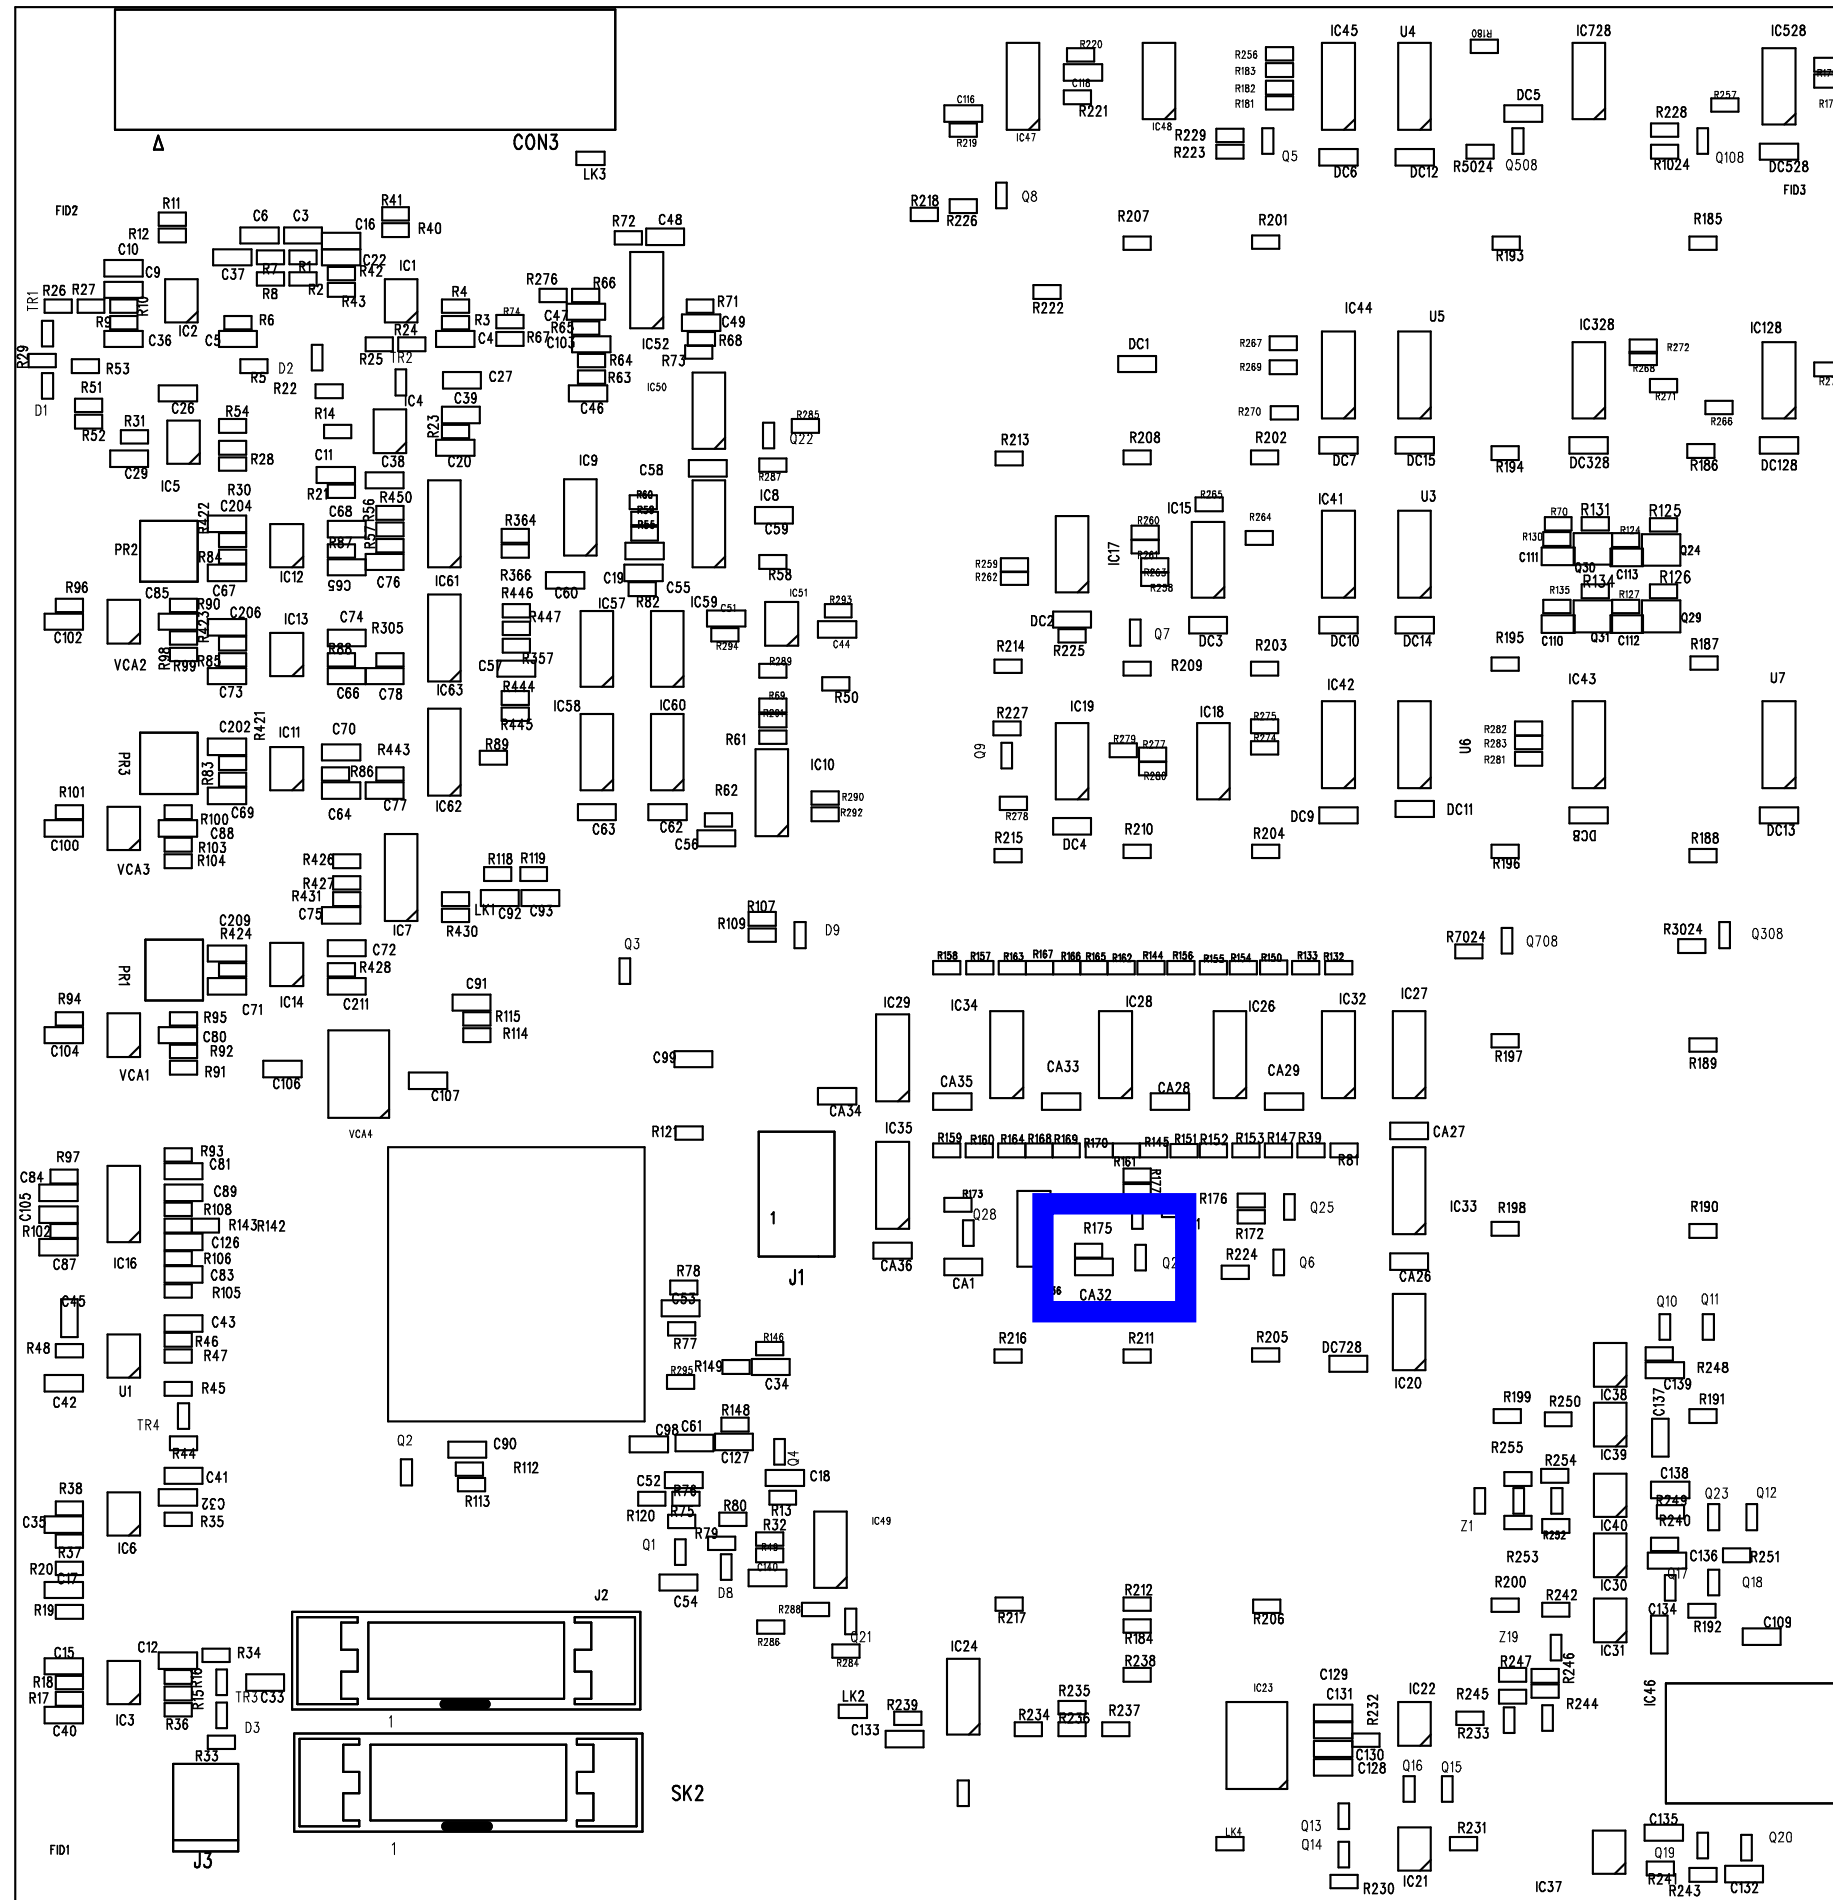
The underside layout of this board with component identification is shown on the next sheet.
