Customer Service Bulletin

January, 1997

SVT-CL/-2PRO

CUSTOMER SERVICE BULLETIN
 ADD CAP. & DIODES FOR
 "FAULT TRIPPING".

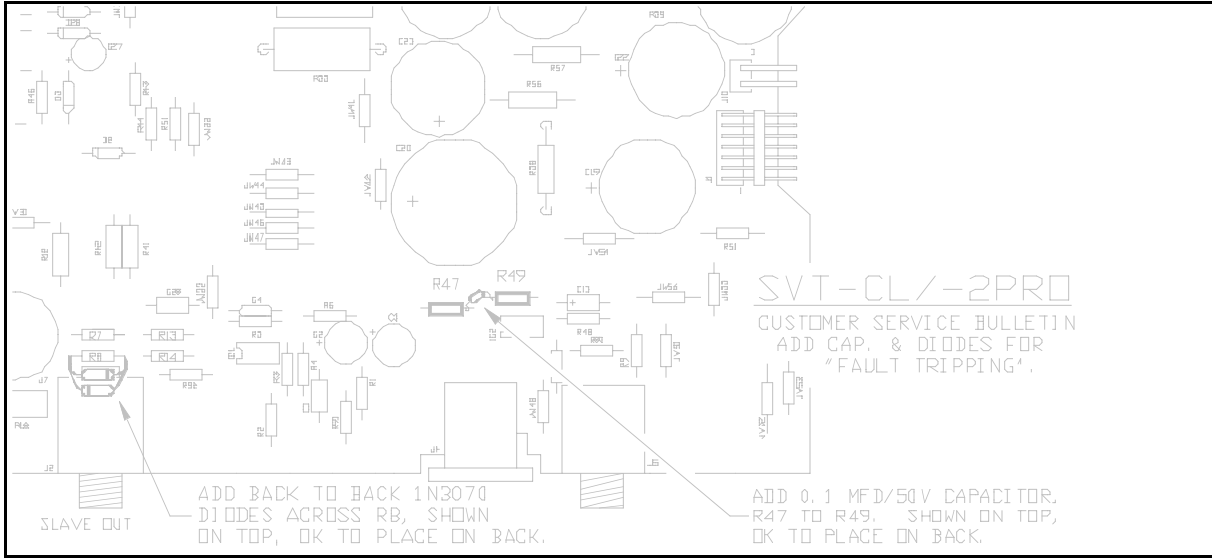
Some units may unnecessarily trip the protection circuitry and cause the unit to go into "fault" mode (i.e. flashing red and green power LED).

Install a .1 mfd/50V capacitor (part # 10A104-01) on the power amp board, as shown below.

Note: This Customer Service Bulletin (CSB) should be done in addition to the one released in March 1995 which added back to back diodes to the power amp input and also changed the gain resistor (R1 audio output PCB) to a 68K 1/4W. For reference the diodes are shown on the figure below. All future runs of these models will incorporate this update.

ADD BACK TO BACK 1N3070
 DIODES ACROSS RB, SHOWN
 ON TOP, OK TO PLACE ON BACK.

ADD 0.1 MFD/50V CAPACITOR,
 R47 TO R49. SHOWN ON TOP,
 OK TO PLACE ON BACK.
