Technical Service Bulletin

Bulletin: PF500 TVS Diode replacment

2/1/2013

PF500

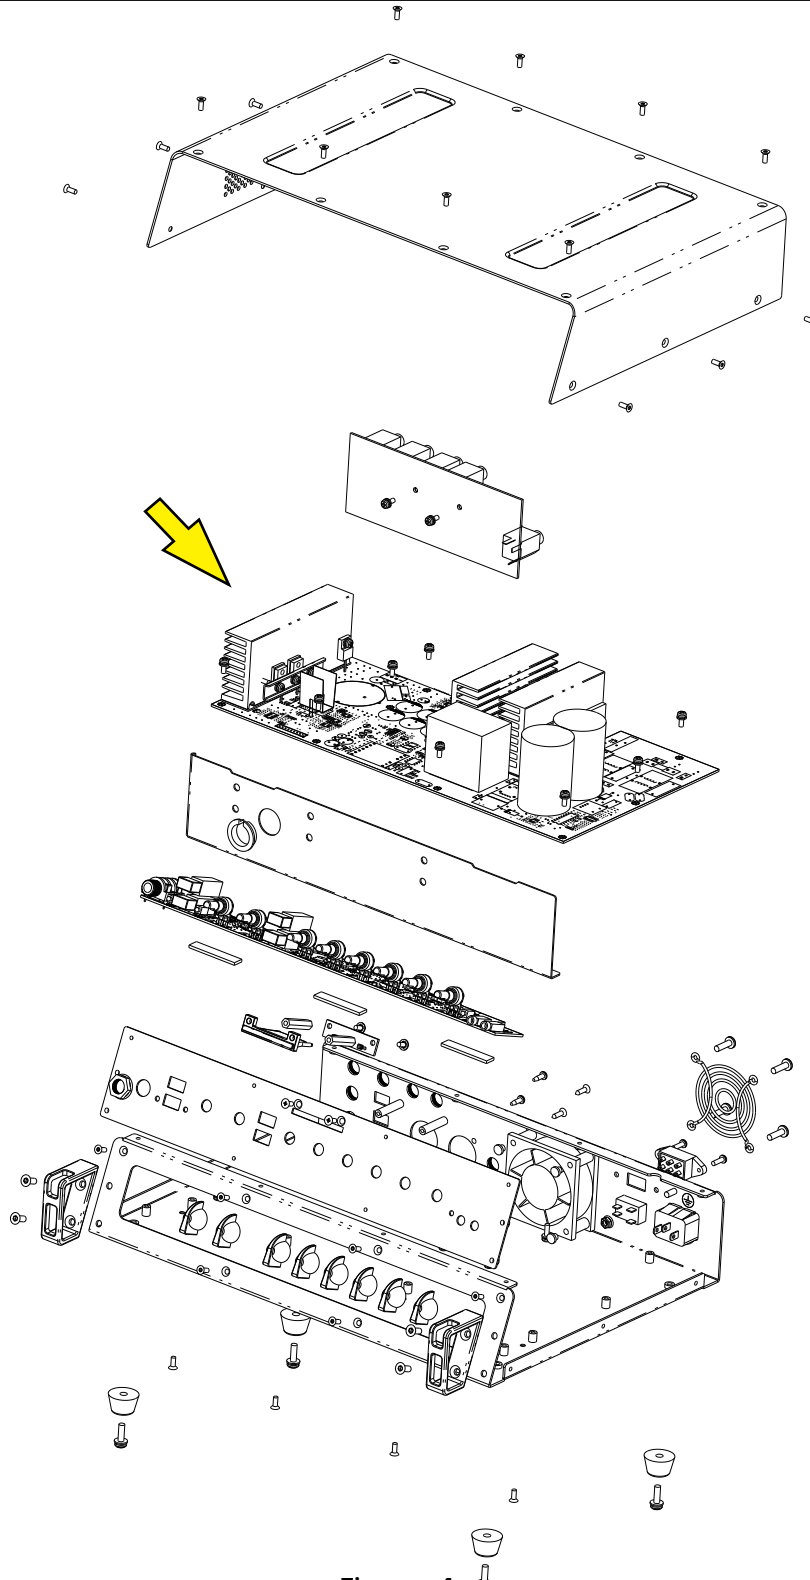
Figure 1a.

1. Disassemble unit, locate and remove board 2034544-XX as seen in figure 1a.

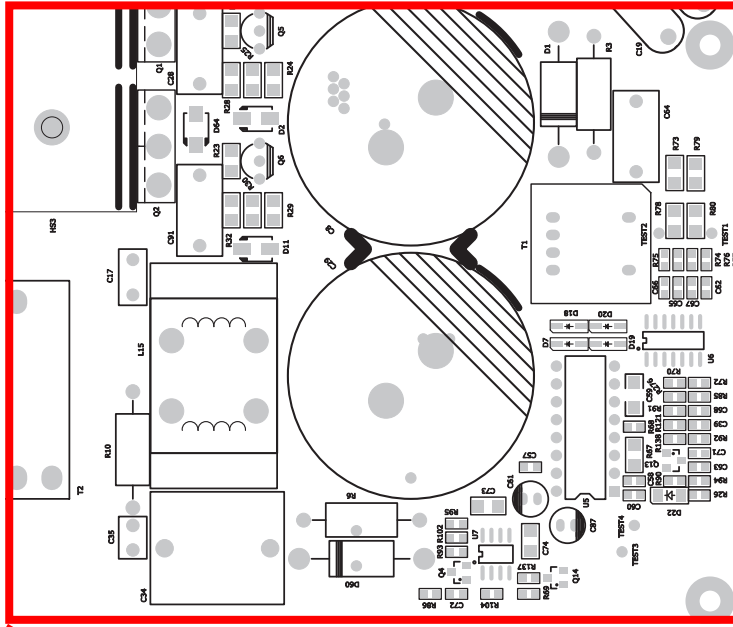
Figure 2a.

2. Place PCB on work appropriate surface and locate diodes D1 and D60. Shown in figures 2a and 2b below. Please take appropriate ESD precautions.

3. Carefully remove both TVS diodes located at D1 and D60. Once removed, clean thru holes and prepare the replacement 1N5404 diodes. Seen in figure 3a.
