LOUD Technologies Inc.

Subject: SWA 1501 Amplifier Service Bulletin

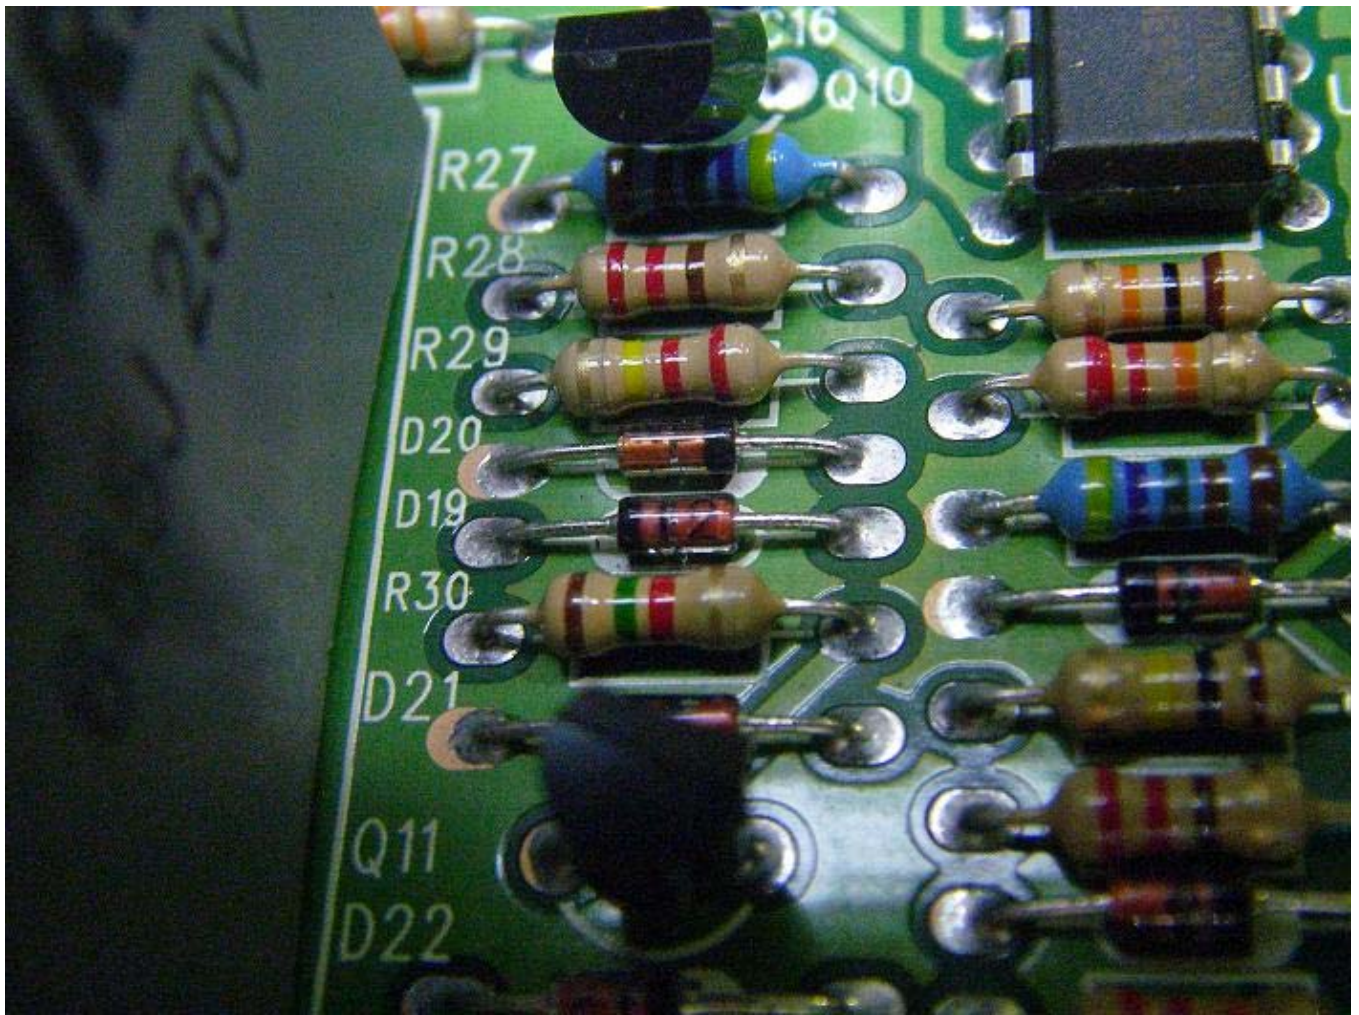
The misprinting of reference designators **D19** (zener diode P/N: 82131050) and **D20** (BAV21 diode P/N: 82112002) on the printed circuit board causes the problem, as the two locations numbers are swapped on the silkscreen. The correct components are being oriented correctly, but end up being in the wrong place. The picture below is an example of the INCORRECT silk screen. The CORRECT silkscreen sequence will be: R27, R28, R29, D19, D20, R30, D21 etc..

When an SWA 1501 is being repaired for any reason, please look at the amplifier assembly and specifically at locations **D19** and **D20**. If the locations are reversed from the schematics, install zener diode P/N: 82131050 in **D20** and install BAV21 diode P/N: 82112002 in **D19**.

The location next to R29 should have the Zener diode P/N: 82131050 installed.
The location next to R30 should have the BAV21 diode P/N: 82112002 installed.
Orientations are indicated by the silk screen, as this is correct.
