Service Bulletin for AVT 100/150/275 Static Problem/Dead OD Channel

STATIC MOD

DWG. No.	SK000126
ISSUE	A

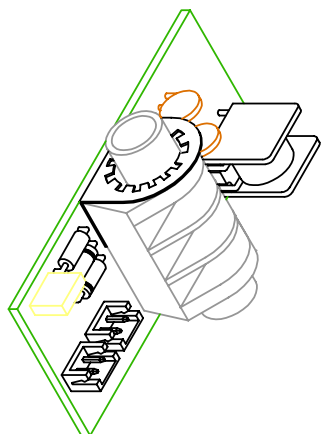
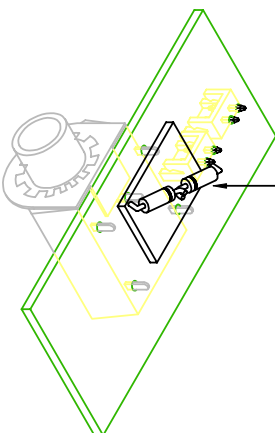
AVT150, AVT150H, AVT275

The problem with overdrive channel failures on the early production runs of AVT 100/150/275's has been identified as being caused by static discharge through the amplifier's input jack socket. An RFC (request for change) procedure has been implemented which will see the fitting of two small zener diodes on the input jack socket boards of these models, which will serve to clamp the static discharge potential to a low, non-destructive level. This will eliminate the present problem. Please view the Static mod schematic on the next page for the correct placement of the two zener diodes.

FIT DIODES AS SHOWN
AFFIX INSULATING PAD
UNDER DIODES.
