Eon 515 Troubleshooting Guide E.Bird/T.Walbert 1-15-09

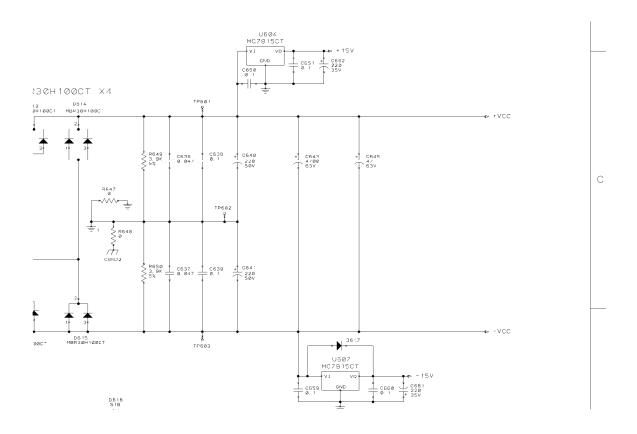
3. Using an ohm-meter measure from TP603 (-VCC) to TP602 (Ground). It should measure over 2K and rising as it charges up the capacitors. If this reads near 0 ohms then you will need to remove the PWA from the heatsink and check for a silpad short or a short between U402 and the heatsink.

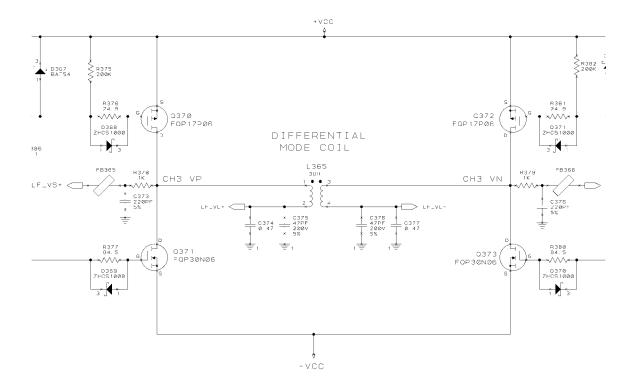
4. Using an ohm-meter measure from TP601 (+VCC) to TP603 (-VCC). It should measure over 2K and rising as it charges up the capacitors. If this reads near 0 ohms, then check Q370, Q371, Q372 and Q373 for shorts, and replace the damaged parts. If two of these MOSFETs are shorted then replacing them is all you will need to do to the amplifier section but you will need to check the power supply for damage.

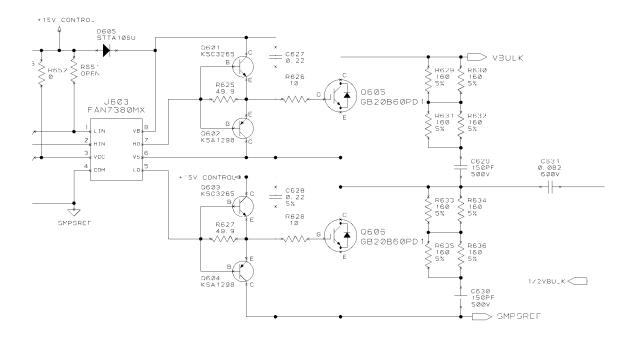
1. Using an ohm-meter check Q605 and Q606 for shorts. If these devices are shorted then check R626 and R628 which should read 10ohms. Next check Q601, Q602, Q603, Q604 for shorts and opens. If any of these are damaged then you will most likely need to replace the following parts along with the ones already identified. U603, R623, R624, U602, U609 and U 601.

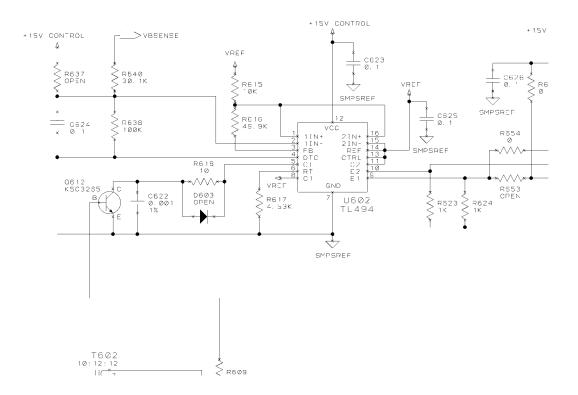
3. Remove the 13V supply and resistor then connect a 300Vdc supply from VBULK to SMPSREF. Verify that the signal at Q606 collector is a 300V peak to peak square wave. The current draw should be less than 70ma.

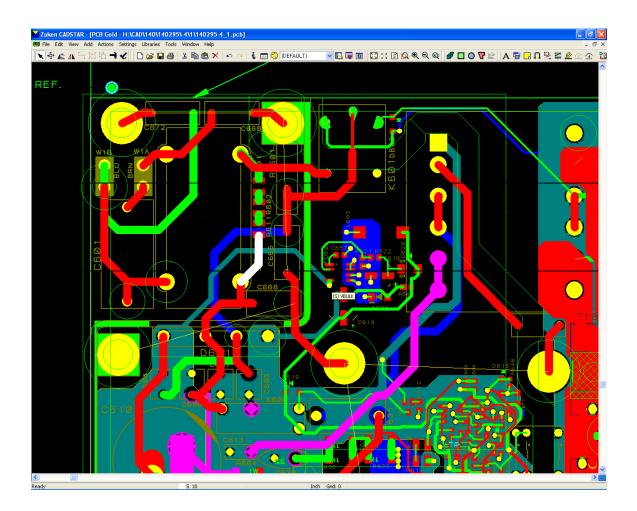
3. 230V power up failures due to a sticking relay. The dominant failure modes observed have been a blown fuse and/or damaged U603. Check for a stuck relay by looking across the contacts of K600 while unpowered for a short between 1/2VBULK and DOUBLER. These can be accessed topside by probing T601 Pin 6 (highlighted in pink and R611 Pin 2 highlighted in white).

In some cases a stuck relay can be "unstuck" by getting knocked about in shipping and will measure ok. It is also worth noting that the bulk caps C610 and C611 can be damaged due to overvoltage stress if powered on at 220-264V with a stuck relay. In this case the unit will power up successfully but will not work when driving a load. Replacing C610 and C611 will remedy this. The auto detect circuitry has been redesigned effective 1/14/09 to prevent a power down glitch which causes the stuck relay.
