Ampeg SVT4-Pro Service Notes

SVT-4 Pro Asset # 003342

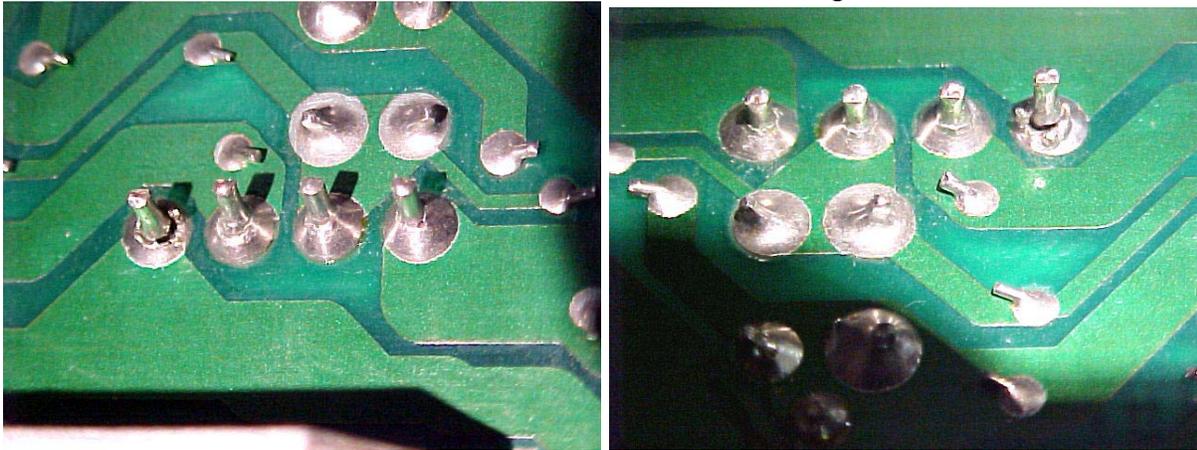
After removal of power amp pcb assy, close inspection of circuit board solder joints revealed severe solder fractures on all 4 leads of main bridge rectifier.

Desoldered, cleaned, resoldered bridge leads. Checked all Mosfets & drivers for blown devices, all ok. Also found two phone jacks on main PCB with solder fractures...repaired. Rest of PCB components ok, reassembled, powered up....130W @ 120VAC at idle. Amp working fine. Checked all functions, sounds nominal.

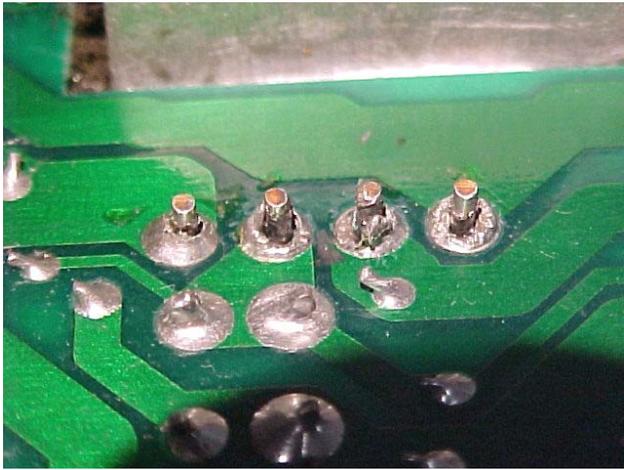
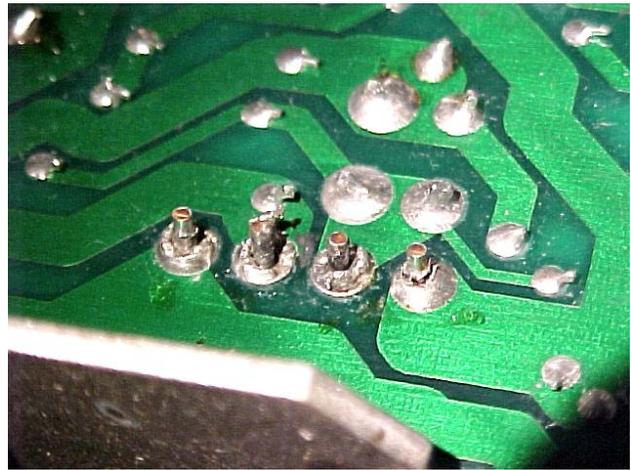
Removed power amp pcb assy, and again, close inspection of circuit board solder joints revealed same severe solder fractures on all 4 leads of main bridge rectifier

Desoldered, cleaned, resoldered bridge leads. Checked all Mosfets & drivers for blown devices, all ok. Rest of PCB components ok, reassembled & powered up...130W @ 120VAC. In checking amp & all functions, found master volume pot gritty, couldn't exercise out noise. Removed preamp PCB assy, removed master volume pot & line out pot, sprayed with Caig DeoxIT D5, exercised, cleaned, reinstalled. Sounds quiet, all works fine again.

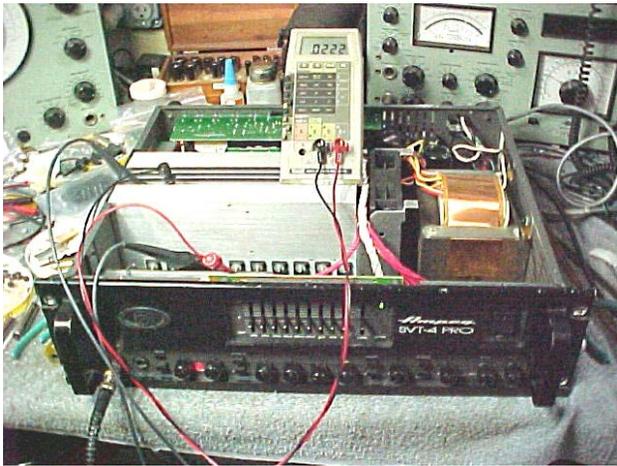
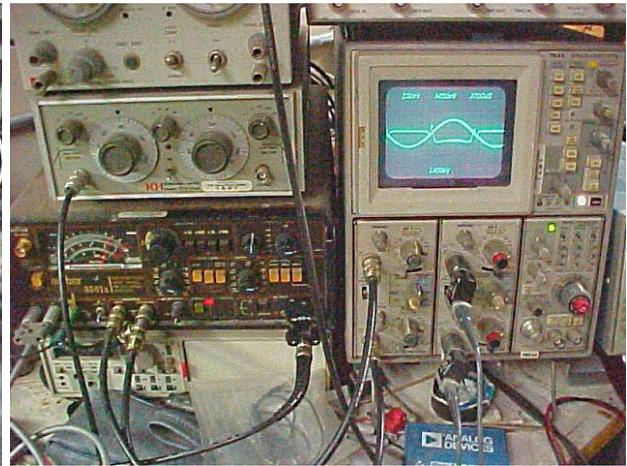
Before I go further, I need to look at the waveform differentially from the output buss to the source terminals of the MosFET's, to see how much more beyond zero-crossing the half-sine wave waveform is there. Measuring that 'envelope with an RMS meter, even after now having the resistance recorded for each of the emitter resistors plus the circuit trace resistance to account for the real IR drop, I suspect I'm accumulating error in trying to measure/compute the output wattage by way of summed currents. I may be able to remove some of the PCB's to get at the rear half of one of the two channels, so I can get the rest of the current distribution. I'd like to post my findings on this.

The waveshape seen differentially across the source resistor is NOT sinusoidal, but rather an offset squarewave, with artifacts.

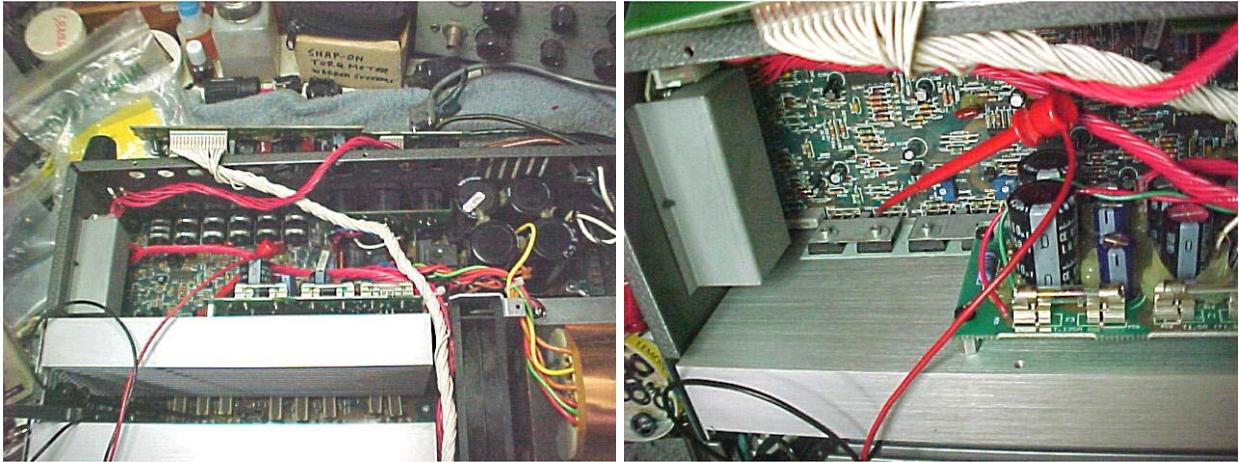
Getting at the back side of the amp channels requires removing the rear top PCB Assy

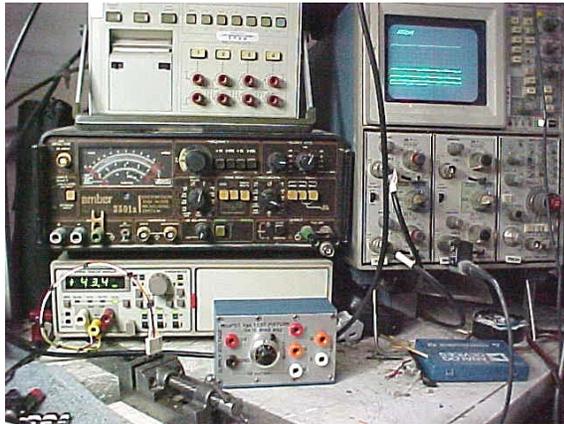
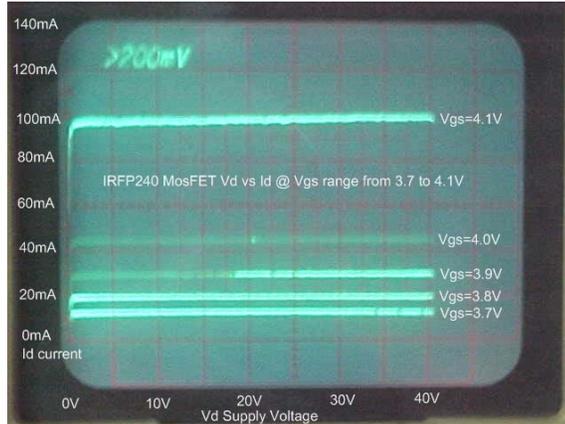
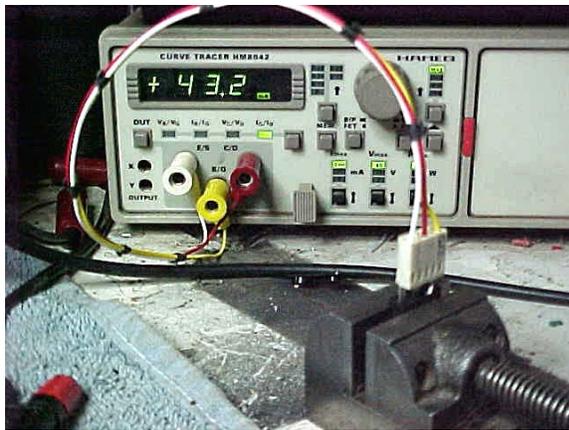
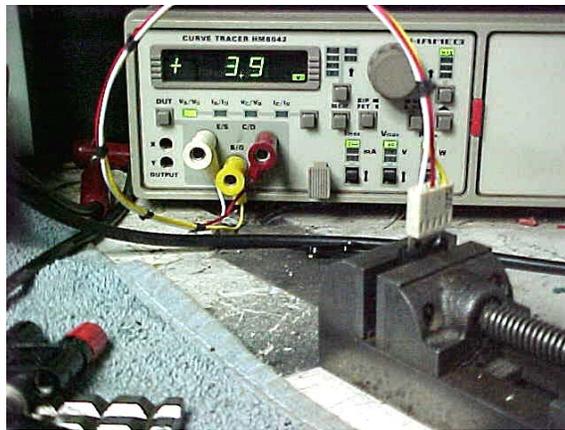
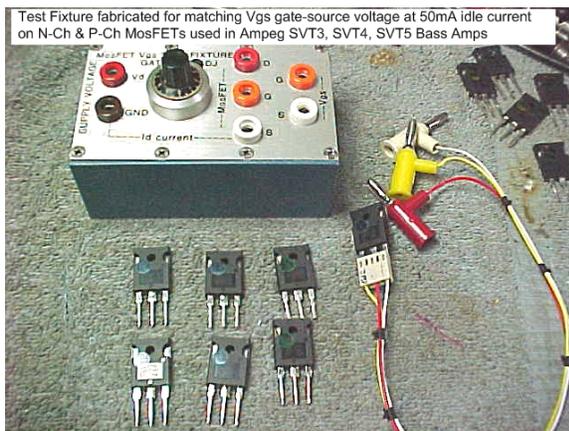
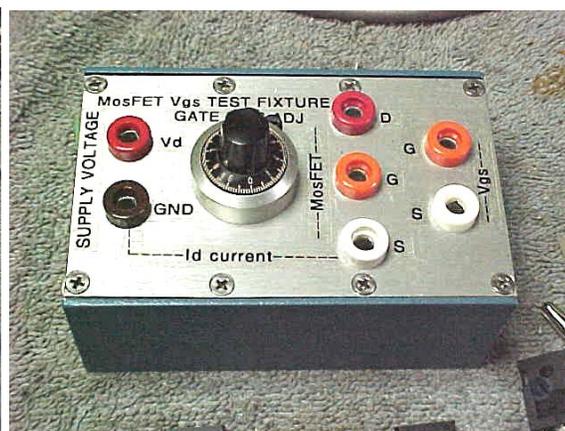
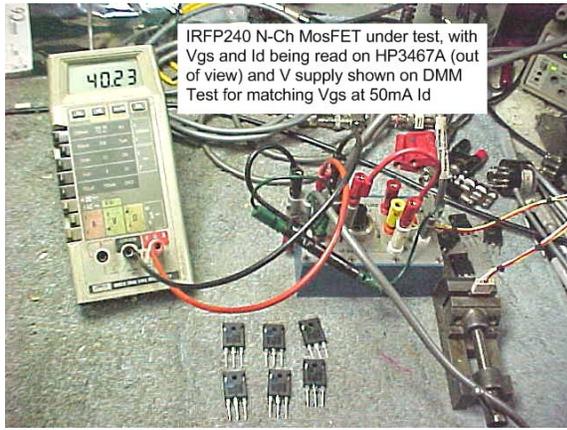
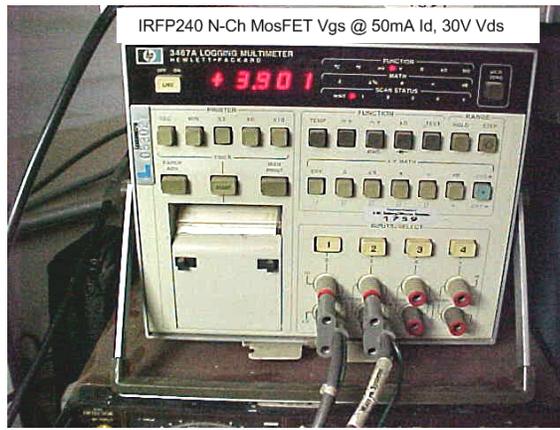
Replaced 3 of the six AAA batteries in the P-Touch label printer, so I could label and then photograph the MosFET V_{gs} Test Fixture & test set-ups.

Both the curve tracer and the Vgs fixture are needed in selecting and matching MosFET's for the Ampeg SVT3 Pro, SVT4-Pro and SVT5-Pro bass amps. With seven unused IRFP240 MosFET's, at 50mA Id & 30V Vds, I found Id ranging (on the curve tracer) from 35mA to 50mA, while Vgs was only varying from 3.92 to 3.93V. Which would I test first, and how do they compare to IRFP9240 P-CH MosFET's? Not yet sure. So far I haven't yet tested any of the P-Ch MosFET's. But at least now I'm in a position to do so with repeatable results. The real test will be to see them in the amplifier. I may want to use the Trygon Dual 40V supply, as I can set the supply voltage for 80V for near-idle operating conditions.

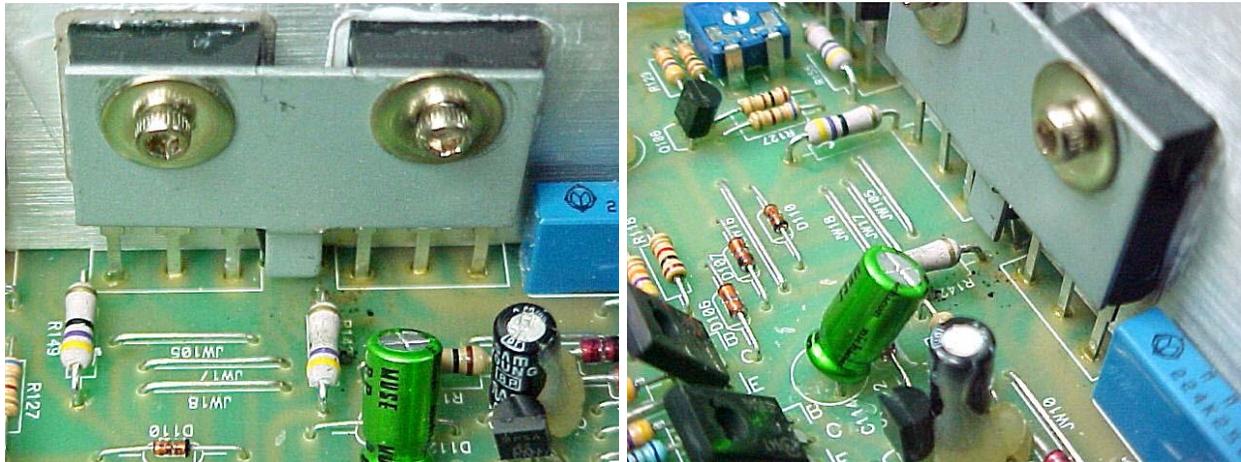
While applying the thermal grease & mica washers, then struggling to get them to pass back thru the PCB and not pull off the solder pads/traces, and registered them, as I went to put the first dual-device clamp into place, I found the finger that forces the TO-92 part up against the heat sink was touching the gate resistor in that same space. I had left the gate resistors proud of the PCB a touch, and, that was enough to make contact with the clamp, putting those at Ground potential! THAT's why I wasn't getting ANY bias! I still don't know why it just suddenly blew, but, that's what it did....cracked the case of the end P-Ch MosFET.

I have re-mounted and soldered in all the parts, but I still need to check all of the support devices due to this fault, and make sure I didn't also short anything else out. From these photos, it looks like I need to double-check that gate resistor, as it has overheated, enough that the black band has nearly disappeared.
