Service Bulletin for AVT 100/150/275 Static Problem/Dead OD Channel

STATIC MOD

DWG. No.	SK000126
ISSUE	A

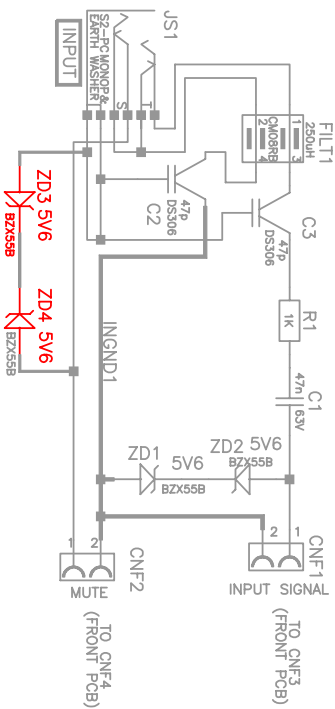
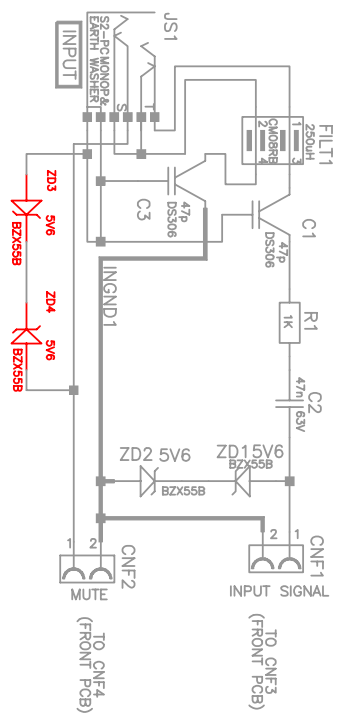
The problem with overdrive channel failures on the early production runs of AVT 100/150/275's has been identified as being caused by static discharge through the amplifier's input jack socket. An RFC (request for change) procedure has been implemented which will see the fitting of two small zener diodes on the input jack socket boards of these models, which will serve to clamp the static discharge potential to a low, non-destructive level. This will eliminate the present problem. Please view the Static mod schematic on the next page for the correct placement of the two zener diodes.

FIT DIODES AS SHOWN
AFFIX INSULATING PAD
UNDER DIODES.
