**BACKSTAGE**  
 BR.# 8902023

REVISED 4/16/84  
 PEAVEY ELECTRONICS CORP  
 MERIDIAN, MS.  
 DRAWN BY *RSB* DATE 11/13/80  
 C.B. CHECK BY *RSB*  
 APPR. BY *RSB*

P/N 81501175

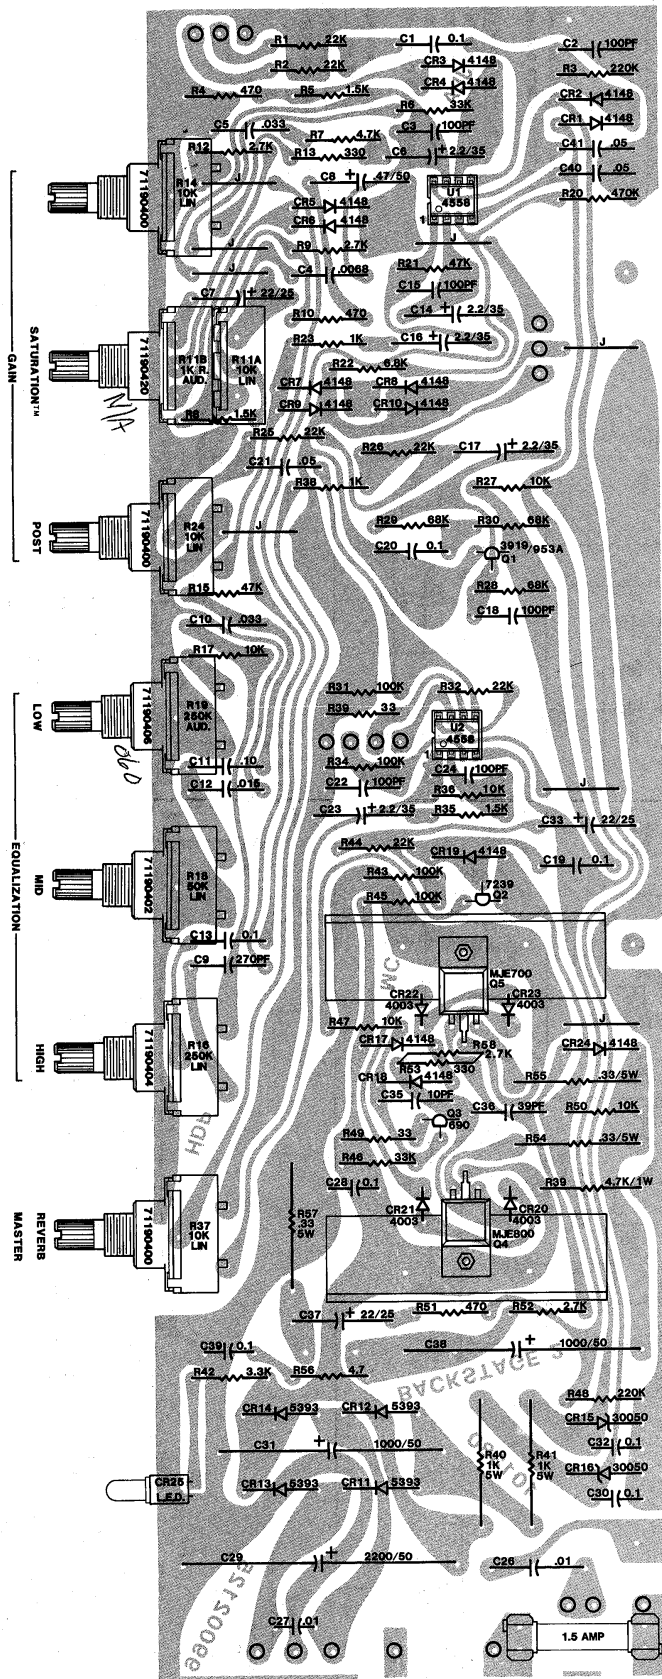
POWER AMPLIFIER CIRCUIT WILL NOT  
 FUNCTION PROPERLY WITHOUT A  
 SPEAKER OR DUMMY LOAD CONNECTED.

- 1) REPLACE R48(220K) WITH A 100K/1/4W
- 2) MAKE SURE R53 IS A 330 OHM.
- 3) ALLOW UNIT TO OPERATE INTO LOAD AT APPROX. 1/2 POWER FOR ABOUT 1 MINUTE.
- 4) REMOVE SIGNAL AND READ THE VOLTAGE ACROSS R53.
- 5) IF THIS VOLTAGE IS ABOVE .006VDC THEN BRIDGE R66 WITH A 2.7K OHM 1/4 WATT RESISTOR.
- 6) IF THE VOLTAGE IS STILL ABOVE .006VDC THEN REMOVE THE 2.7K AND TRY A 1.5K 1/2WATT RESISTOR.

NOTE: HIGH IDLE CURRENT MAYBE THE  
 RESULT OF SOME LEAKY COMPONENT  
 ELSEWHERE IN THE POWER AMP  
 THIS SHOULD BE TAKEN INTO  
 CONSIDERATION BEFORE MODIFYING.
